Renishaw's inspection tools optimise VMC precision for Haas

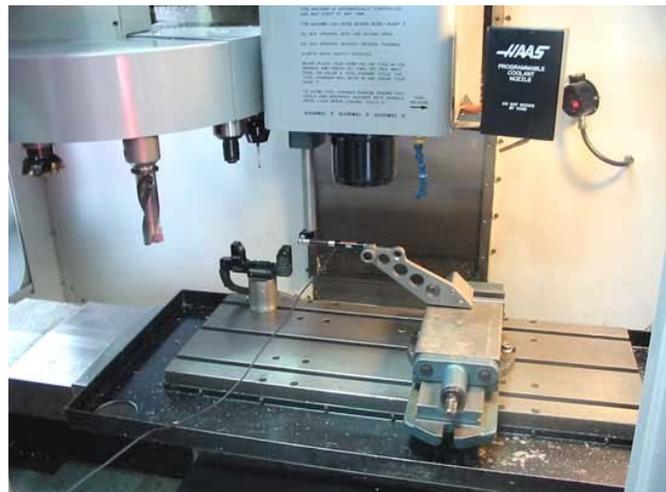
QC10 ballbar testing positioning performance on a HAAS VMC

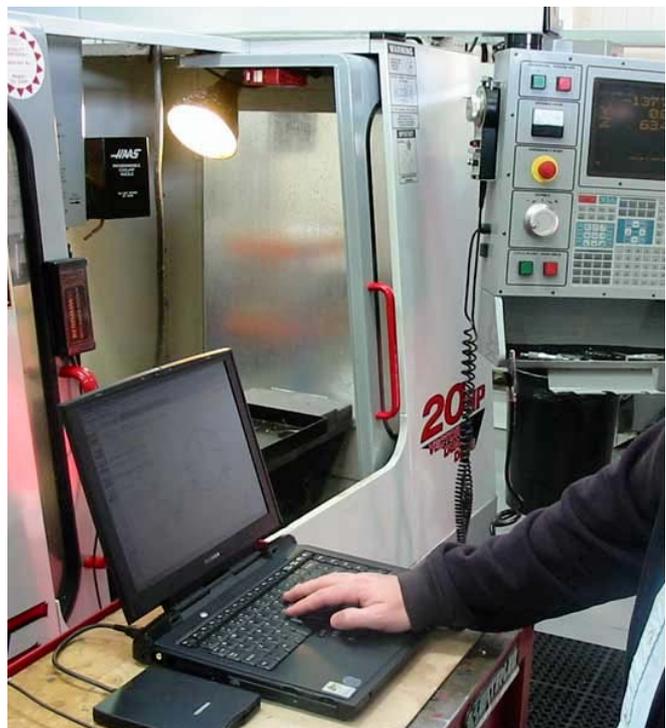
The QC10 ballbar test is controlled with software on a PC, the data gathered will then be analysed with Ballbar diagnostic software off-line

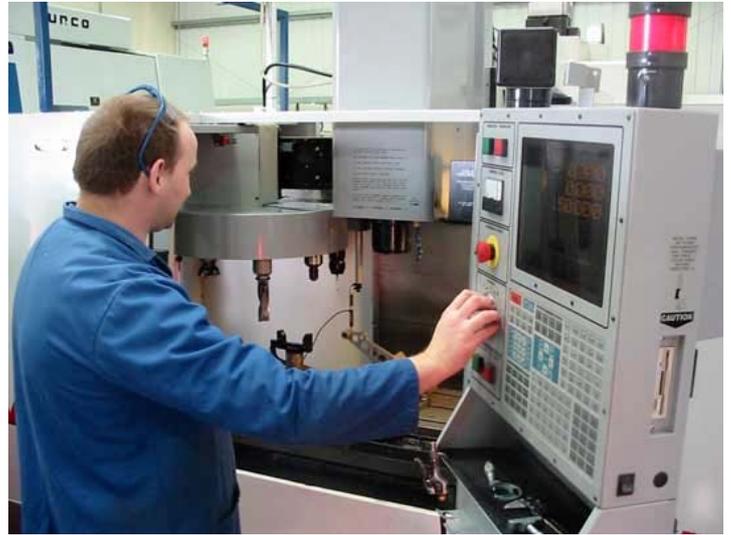
Following the ballbar test, adjustments can be made and the machine re-tested to provide a bench-mark for on-going historical analysis of the positioning performance, allowing predictive maintenance
